Project "SOPHIA-2" – Final Report (public version)

Meteomatics

Report Overview

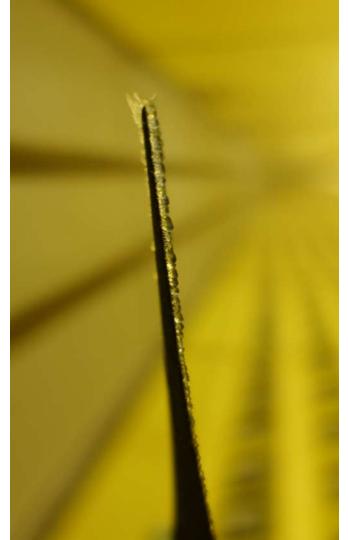
Formation of ice on propeller under specific set of laboratory conditions

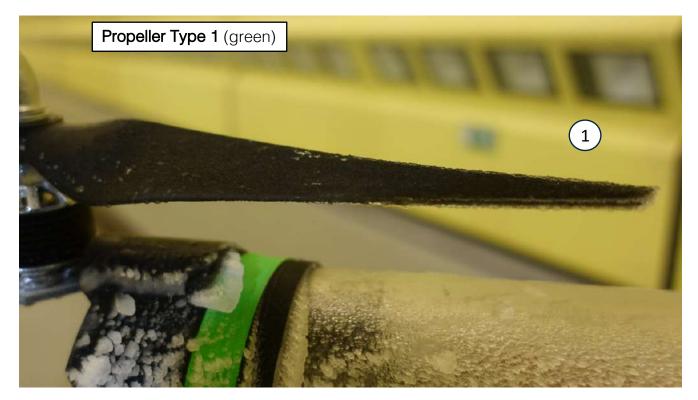
^{1 –} after 30 sec: uniform ice film has already grown on propeller

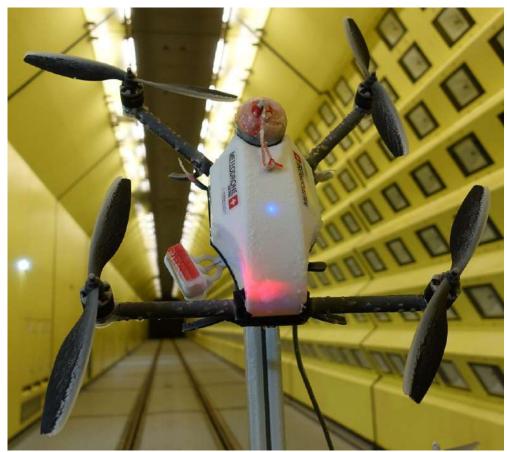
- Several tilt angles were measured for the drone, simulating different orientations towards the wind direction from the icing tunnel
- As can be seen from the image on the left, the results show that although, depending on the angle, icing occurs less heavily on the propeller blades, the rotor edges are still the bottle neck when it comes to icing conditions
- In conclusions this means that the air flow due to the movement of the drone is of minor importance for the formation of ice on the propellers
- The hull experiences more icing when turned directly towards the air stream as would be expected, since its area of exposure increases

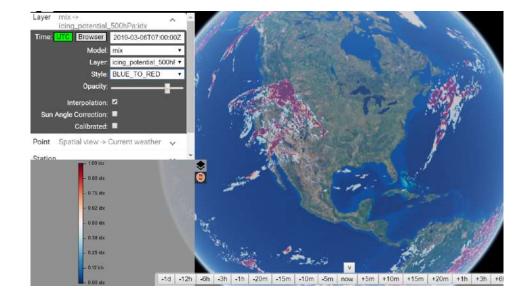
A Comparison with AWC: 500 hPa / 18'000ft

Icing potential index over North America, 06 Mar 2019, 07:00 (nowcast) from Meteomatics (left) and NOAA (right). 500hPa respectively 17000ft.
